Case Study

Restoration - Kings Sterndale

Project: Sympathetic Restoration – Phase 1

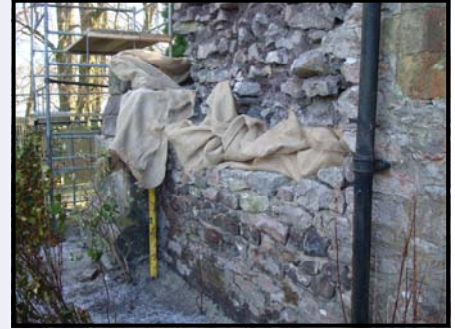
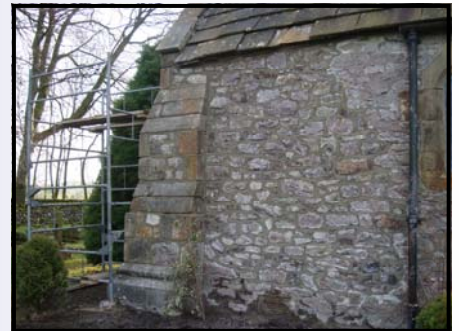
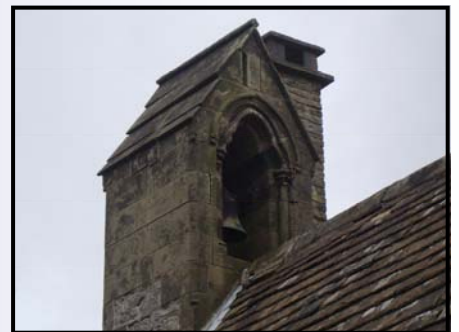
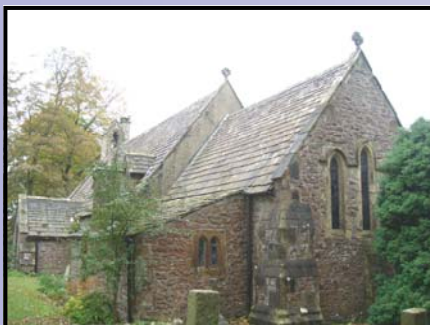
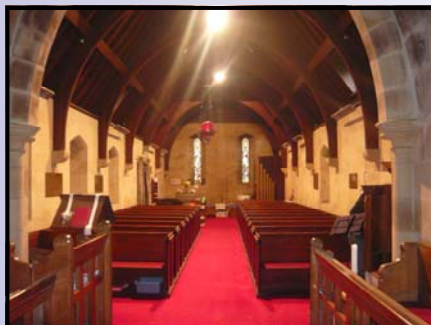
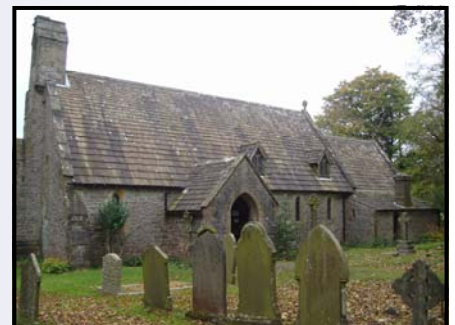
The church was in need of urgent structural repairs. Bulging walls and buttresses were numbered and photographed. Stone work was carefully dismantled and re-built using hydraulic lime and limestone dust mix.

- Structural ties
- Re-building the nave west wall and adjoining buttress.
- Structural repairs to the channel north wall.
- General re-pointing
- Stonework repairs
- Roof repairs
