Case Study

Bridge Repairs- National Trust

Location: Calke Abbey Estate, Derbyshire

Project: Structural Repairs & Maintenance

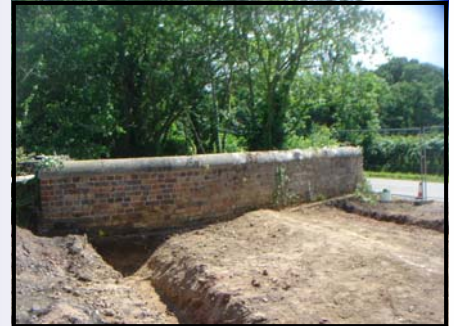
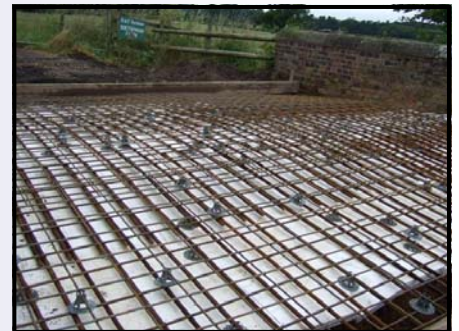
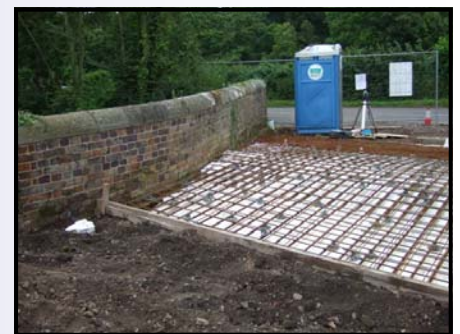
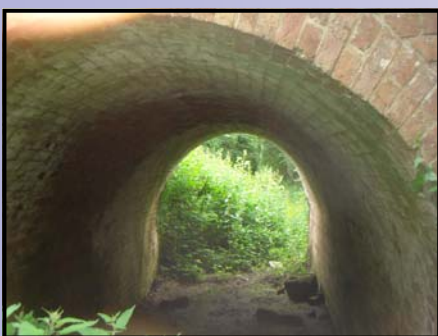
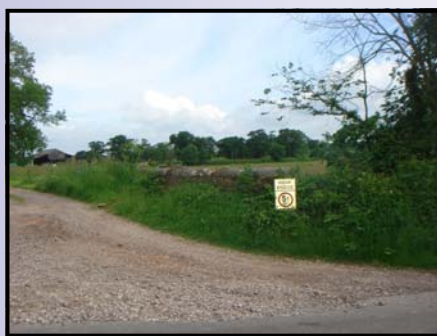
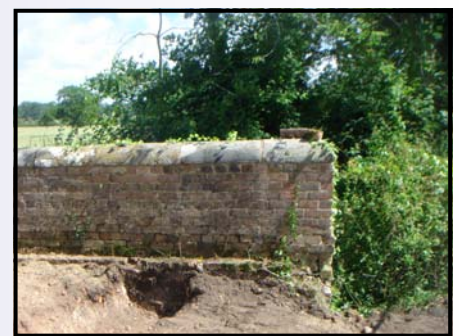
Bridge Number 1 lies within the National Trust's Calke Abbey Estate, a typical working country estate. The bridge had deteriorated over time due to the increased loading of farm traffic since the bridge was initially constructed.

Working to very strict controls the project involved preparing the existing ground and bridge barrel arch to accept a new reinforced concrete slab that spans the width of the bridge to help spread the load when vehicles cross.

Once the concrete slab had sufficiently cured. A new tarmac finish was laid down and seamlessly worked into the existing road to a fine finish.

Sections of the wall were re-built and the whole bridge was re-pointed with lime mortar to ensure it would not deteriorate any further.
